ARIZONA WELLS: MAINTAINING AND TROUBLESHOOTING WELLS

Janick F. Artiola, Ph.D.; Kristine Uhlman, RG; and Gary L. Hix, RG

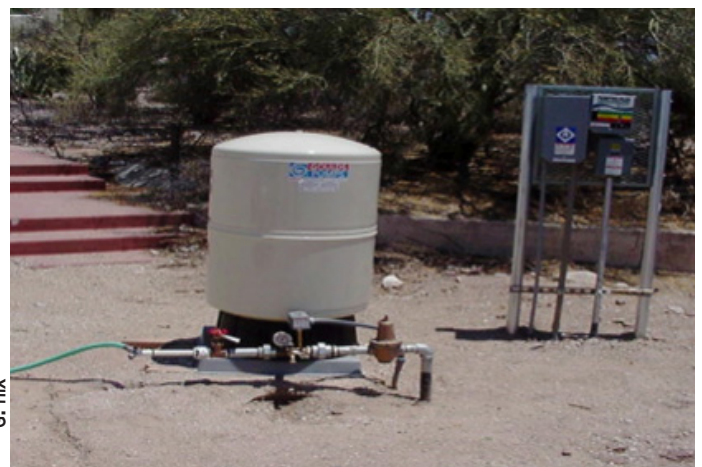
Figure 1. Typical Domestic Well System with Pressure Tank

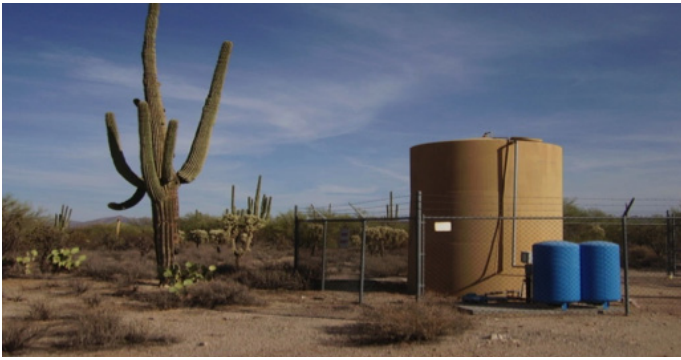
Figure 2. Typical Domestic Well System with Storage and Two Pressure Tanks, and Booster Pumps.

If the sustained yield of the well is insufficient for the landowner's immediate needs, water storage tanks and secondary booster systems are constructed to provide higher flow rates. If the sustained yield of the well and pumping equipment is sufficient for the homeowner's needs a smaller water system can provide the needed water.
